Manhole Inspection Summary

Manhole # S25GG1078MH

Location Address: **1020 41ST ST**

Cross Street: **HICKORY AVE**

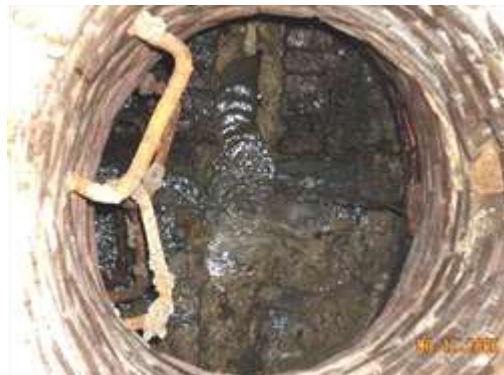
Top View

Corroded steps. Bench and Channel debris.

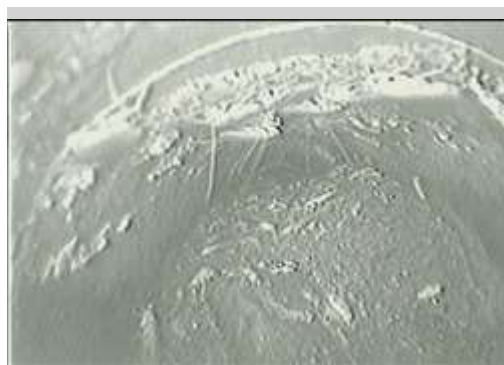
Inside the I6

Root ball.

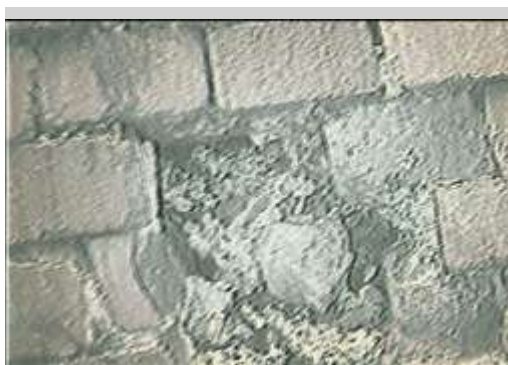
Defect

Hole in Barrel wall.

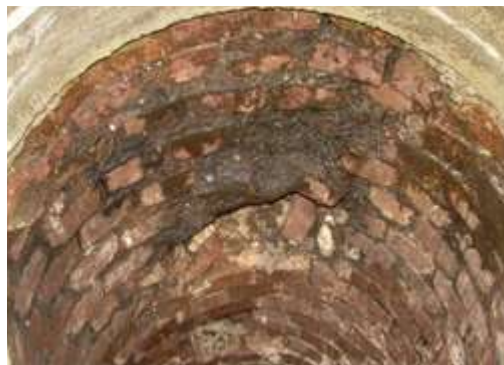
Defect

Adjustment deterioration and infiltration. Corbel infiltration. Barrel deterioration and infiltration.

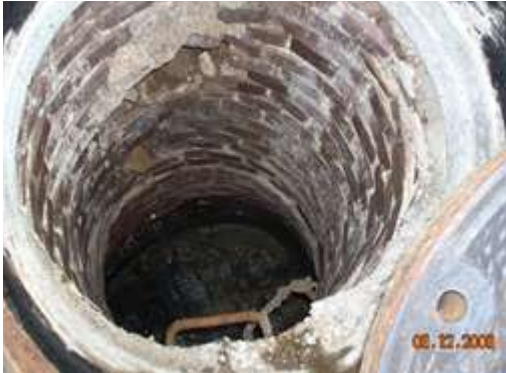
Defect

Adjustment deterioration and infiltration.
Corbel infiltration - other side.

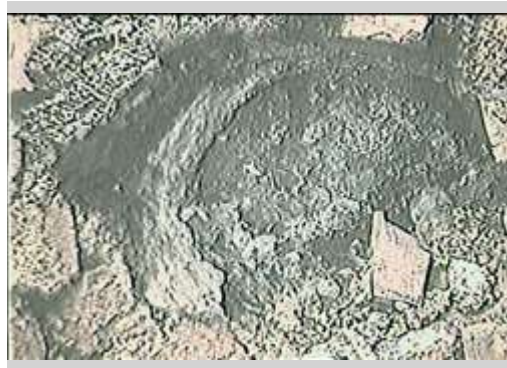
Defect

Abandoned pipe - Also in the I3 position.

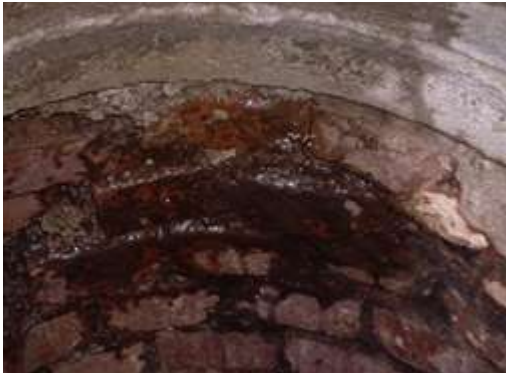
Defect

Adjustment deterioration and infiltration.
Corbel infiltration.

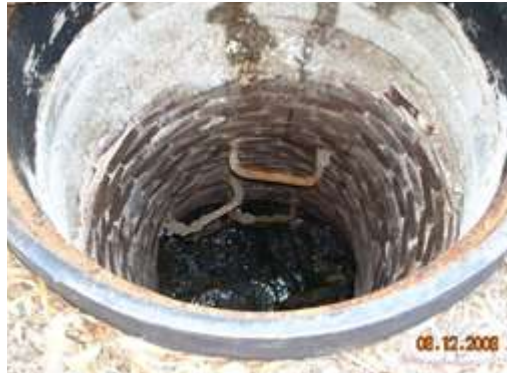
Defect

Adjustment deterioration and infiltration.
Corbel infiltration.

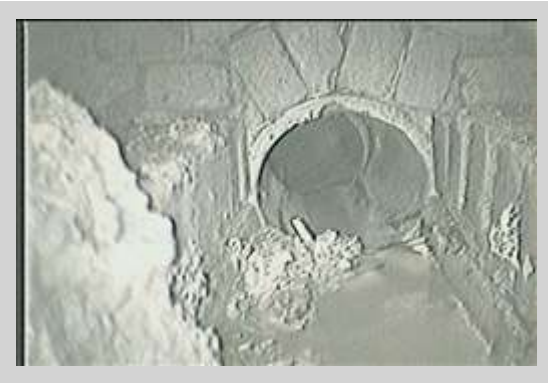
8 in. Circular Gravity Sewer Pipe Out @ 12 O'Clock

Barrel deterioration and infiltration. Channel deterioration.

Deposits: ☐ None ☐ Mud ☐ Sludge ☐ Debris ☒ Grease

Silt Depth: **0** (in.) Deposits Extent: **Light**

Infiltration: **Evidence** Pipe Seal Cond: **Cracked**

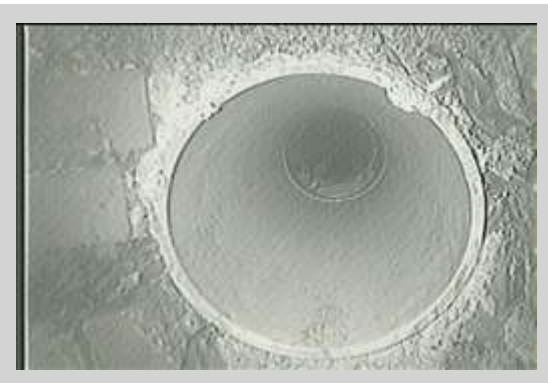
8 in. Circular Gravity Sewer Pipe In @ 3 O'Clock

Infiltration: **None** Pipe Seal Cond: **Unknown**

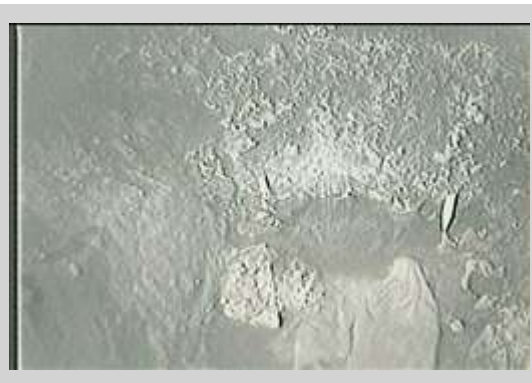
Drop In @ 3 O'Clock

Drop Condition: **Open**

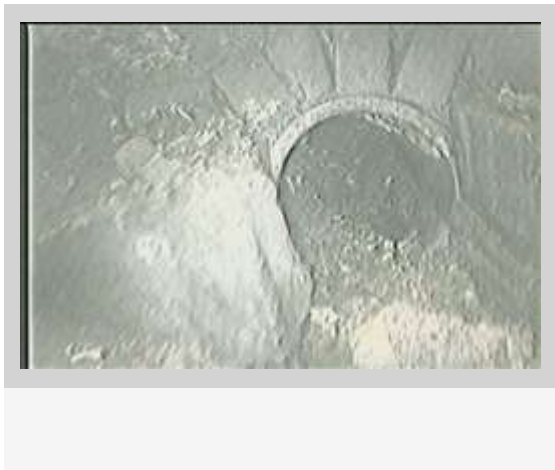
8 in. Circular Gravity Sewer
Pipe In @ 6 O'Clock

Infiltration: **Evidence** Pipe Seal Cond: **Unknown**

Connects To: **Stub connection / abandoned**
